## State of Utah DEPARTMENT OF NATURAL RESOURCES Division of Oil, Gas & Mining

### **Inspection Report**

Mine Name: White Cap #8	Permit number: S0150047	
Operator Name: Gypsum Resource Development	Inspection Date: April 12, 2007	
	Time: 12:00 12:30 PM

S0150047, White Cap #8 Mine, Gypsum Resource Development Inspection Dated: April 12, 2007; Report Dated: April 17, 2007

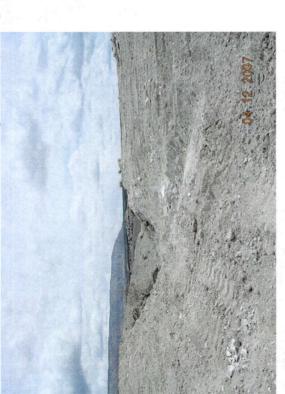
The drainage the traverses the mine was graded so I believe there is nothing to block the water. Without surveying equipment it was impossible to tell for sure, but even if there are slight rises, they should quickly fill with sediment or erode. Photos 1 and 2 show where the drainage leaves and comes on to the reclaimed area.

Photo 1. This is where the drainage exits the disturbed area.

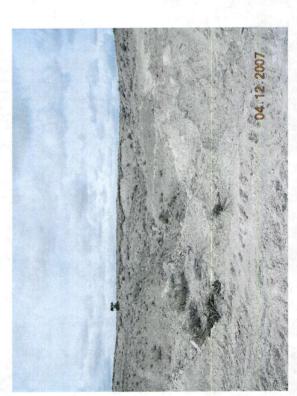
Photo 2. This is where one of the drainages enters the disturbed area.

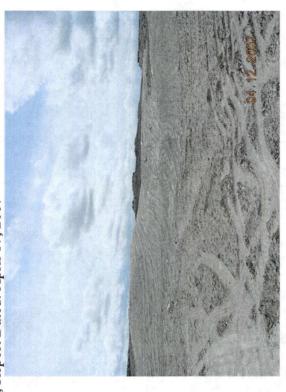
The overall grading is shown in Photos 3 and 4. The area blends well with surrounding areas, and it is essentially a large swale. Parts of the disturbed area are smooth, but the vast majority is very rough. Some large rocks were left on the surface, but I would like to have seen more smaller rocks to help control erosion, increase infiltration, and enhance plant growth.

There are some tracks on the regraded area near the road.

Photo 3. The overall regraded area. Note the tracks in the foreground.

I have some concerns whether people will ride OHVs on the reclaimed area. If this is a problem, it might be necessary to build a trench near the road. I suggest that the operator install at least one sign asking that people stay off the reclaimed area.

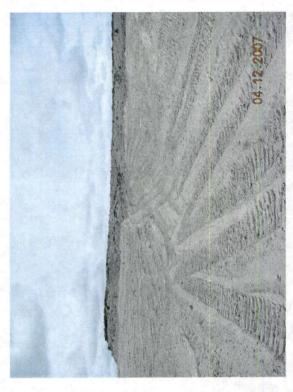
Photo 4. The upper portion of the regraded area.
